Manhole Inspection Summary

Manhole # S31AA1020MH

Insp Date: **5/30/07 11:51 AM**

Location Address: **SAN MARTIN DR**

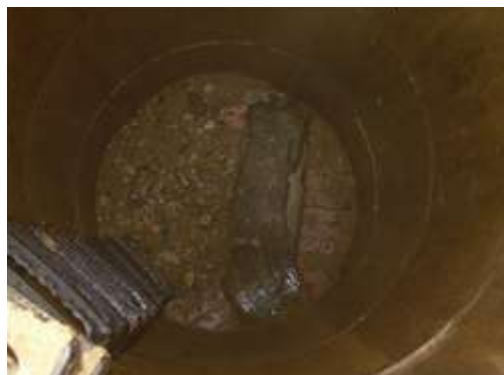
Top View

Bench ☒ Exists Material: **Brick** ☐ Parged ☒ **Debris** (not Condition related)

Channel Material: **Brick** ☐ Parged ☒ **Debris** (not Condition related)

Bench and Channel debris.

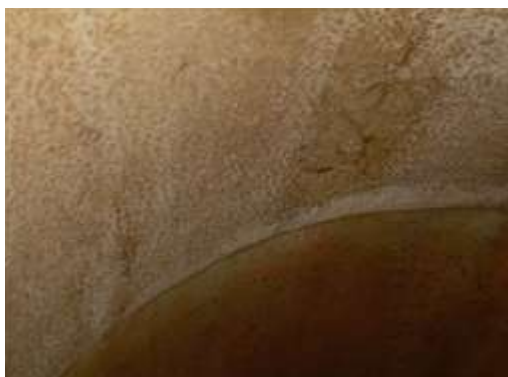
Defect

Infiltration: ☐ None ☒ **Joint** ☐ Cracks ☐ Mortar ☐ Roots ☐ Wall

Corbel and Barrel infiltration.

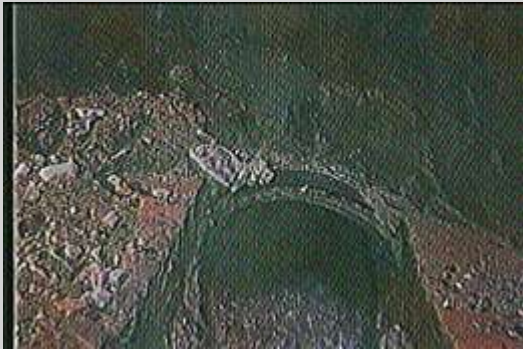
12 in. Circular Gravity Sewer Pipe Out @ 12 O'Clock

Infiltration: **None** Pipe Seal Cond: **Cracked**

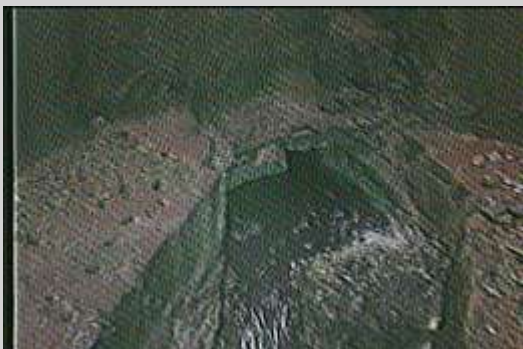
12 in. Circular Gravity Sewer Pipe In @ 5 O'Clock

Infiltration: **Evidence** Pipe Seal Cond: **Broken**
